COUNTY OF WETASKIWIN
REPORT NUMBER: 181-10883-00

NEPL WASTEWATER & INFRASTRUCTURE ASSESSMENT FINAL DRAFT

MAY 01, 2019

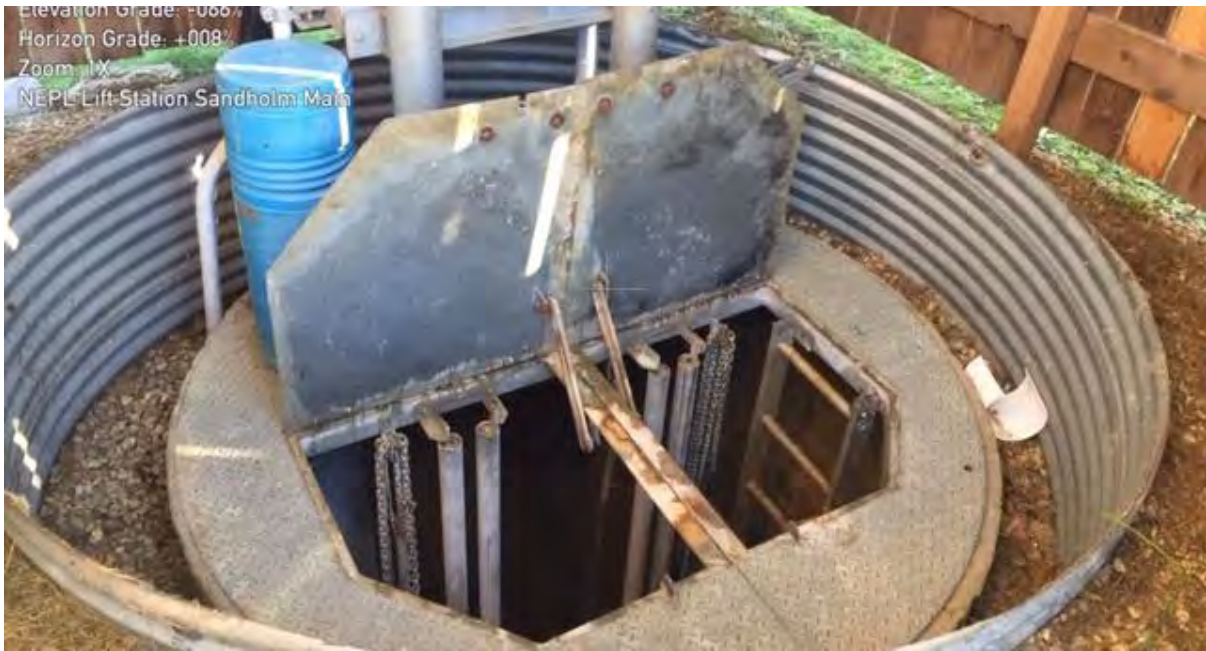
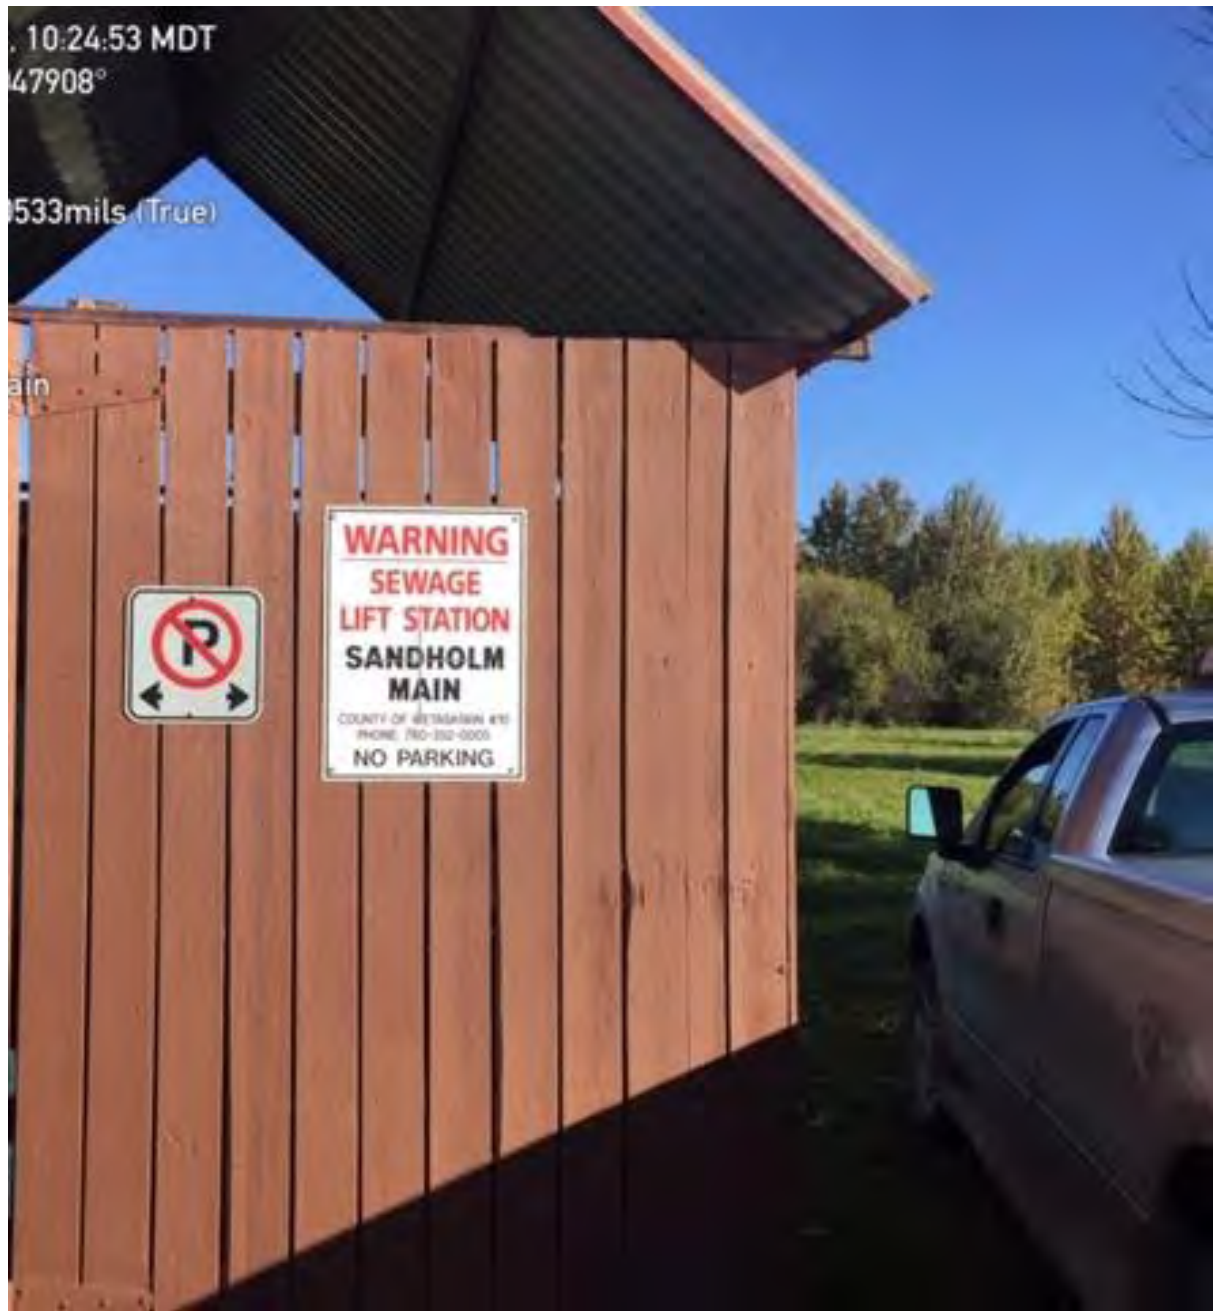
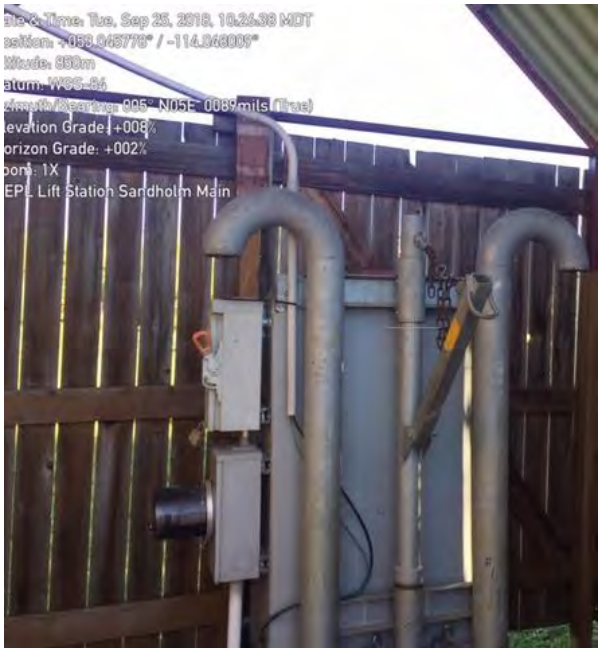
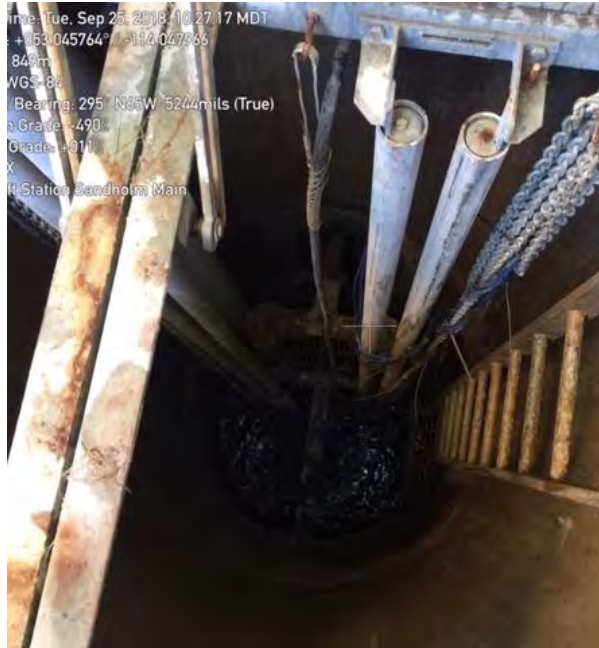
SANDHOLM MAIN LIFT STATION		County of Wetaskiwin North East Pigeon Lake Wastewater Collection System Assessment		Approx. year of installation	Typ. Life Expectancy (yrs)	Condition Grade	estimate remaining life (yrs)	Estimated costs in next 2+ years	Estimated costs in next 5+ years	Estimated costs in 10+ years
2018	Component	Description	Comments							
Sanitary Lift Station Assessment	Layout	Drawings	Flight package lift station, drawings are available	drawings are dated 1990						
		Safety/security	Site is Locked, Electrical panel has access security, site has alarm call outs.	site is secure	N/A	N/A	N/A	N/A	N/A	N/A
		Shelter	Site has a wood fence with a tin roof mounted on fence. Roof has open gable ends.	Fence and roof are in good condition	N/A	10+	1	5+	\$2,000.00	
		Site location	Located just off Wicks Street on a utility right of way, set back from the road with a small gravel service access	N/A

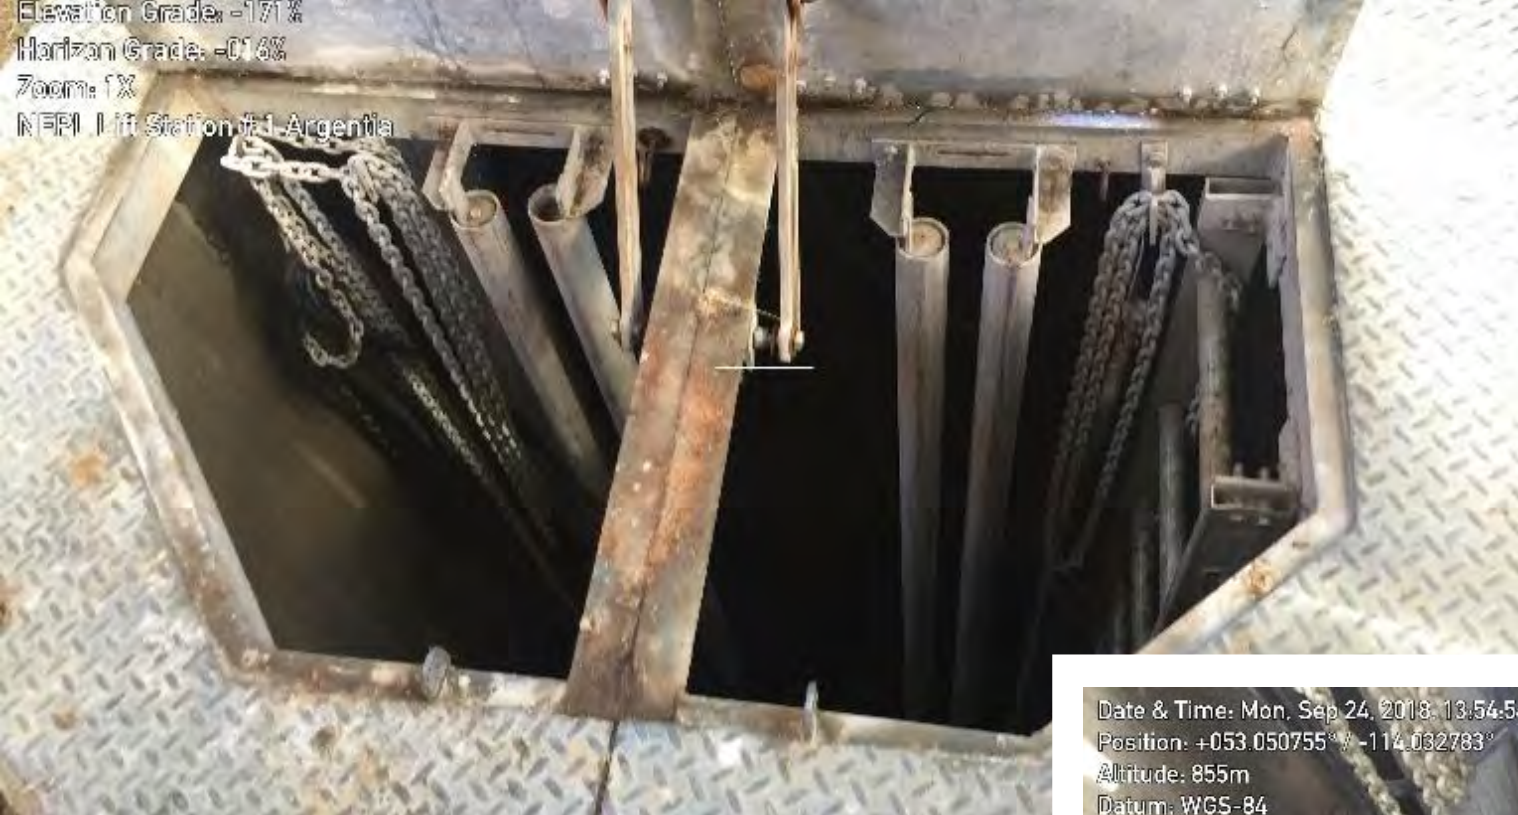
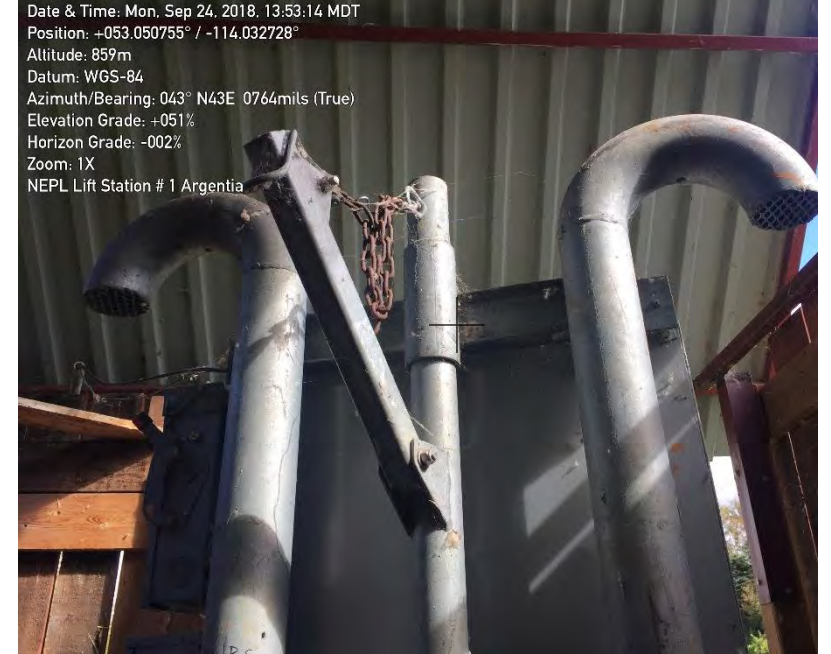
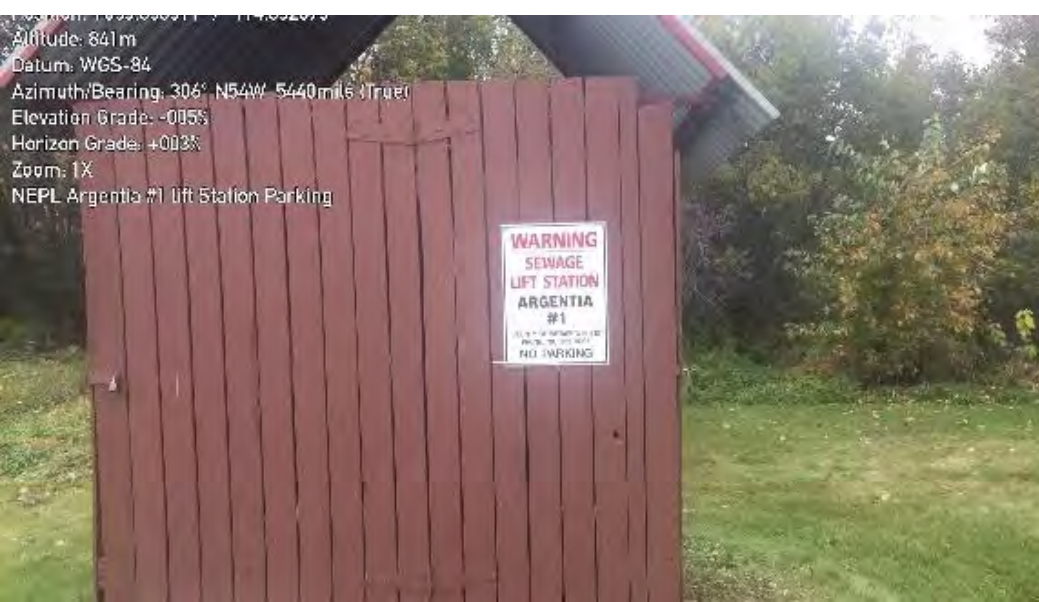
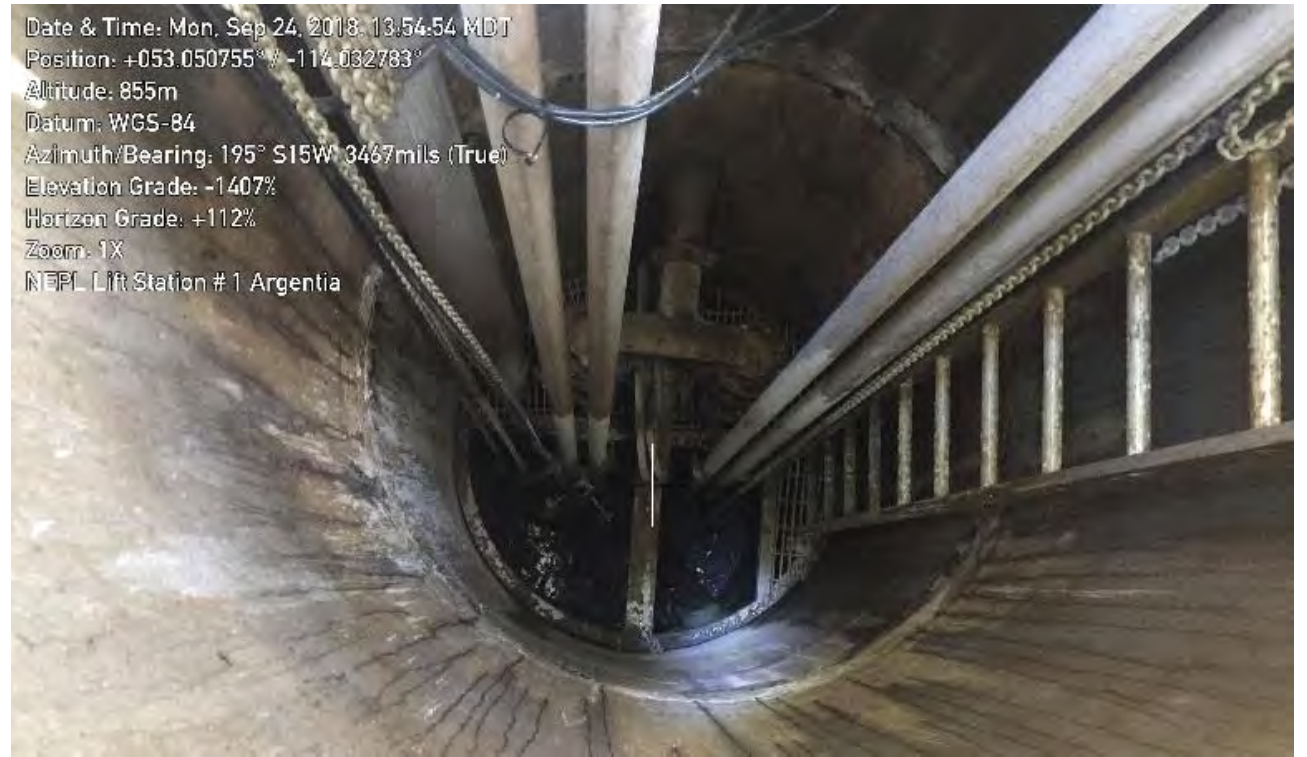
ARGENTIA BEACH LIFT STATION #1		County of Wetaskiwin North East Pigeon Lake Wastewater Collection System Assessment		Approx. year of installation	Typ. Life Expectancy (yrs)	Condition Grade	estimate remaining life (yrs)	Estimated costs in next 2+ years	Estimated costs in next 5+ years	Estimated costs in 10+ years
2018	Component	Description	Comments							
Sanitary Lift Station Assessment	Layout	Drawings	Flight package lift station, drawings are available	drawings are dated 1989						
		Safety/security	Site is Locked, Electrical panel has access security, site has alarm call outs.	site is secure	N/A	N/A	N/A	N/A	N/A	N/A
		Shelter	Site has a wood fence with a tin roof mounted on fence. Roof has open gable ends.	Fence and roof are in good condition	N/A	10+	1	5+	\$2,000.00	
		Site location	Located just off 59th Ave on the edge of the road right of way.	N/A						
	Wet Well information	Dimensions	The wet well is 1.65m inside diameter, and total depth is 6.09 m from lid to WW floor. Active storage depth is 1.79m	N/A

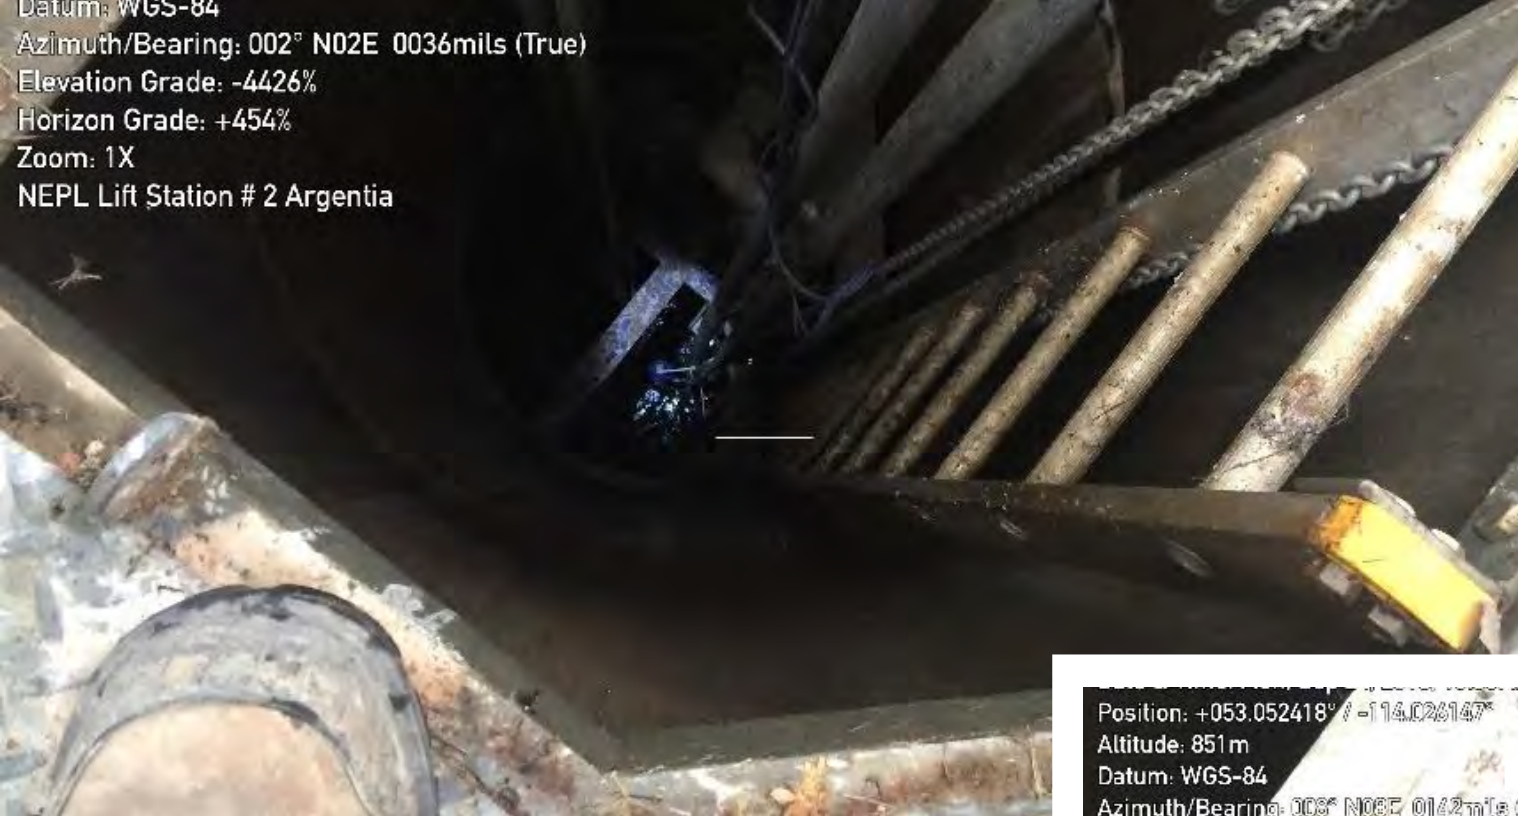
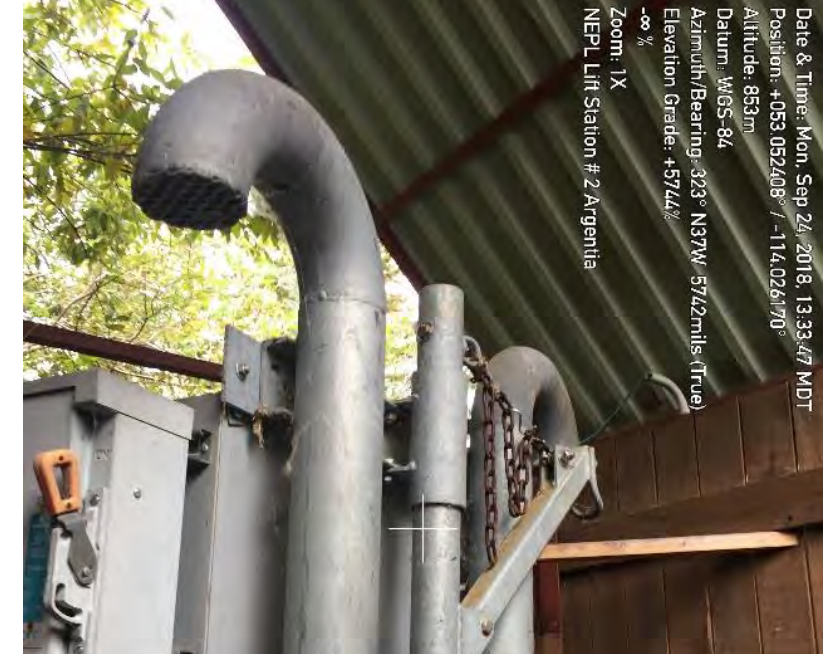
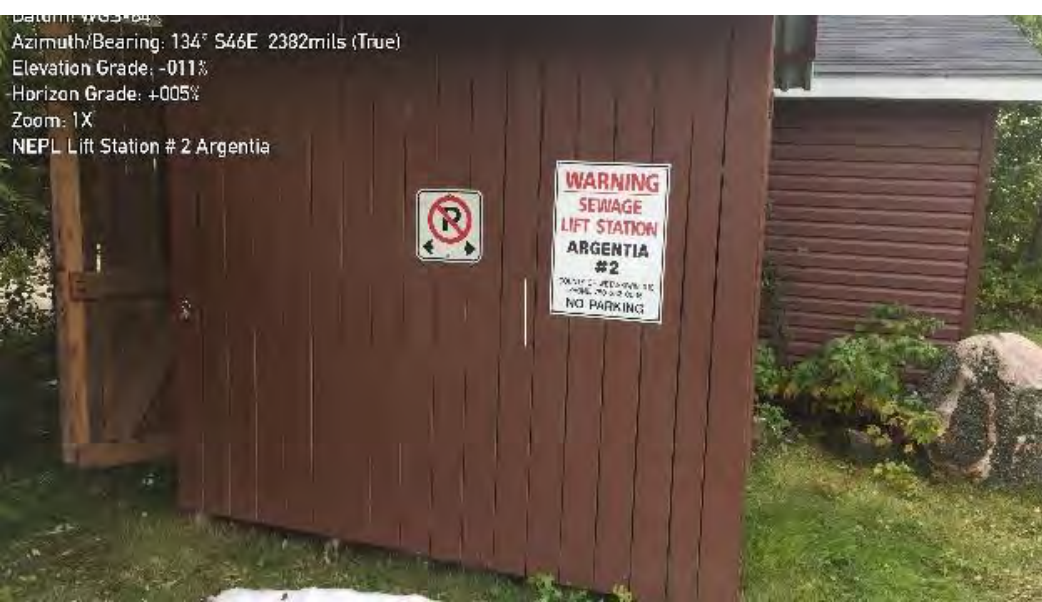
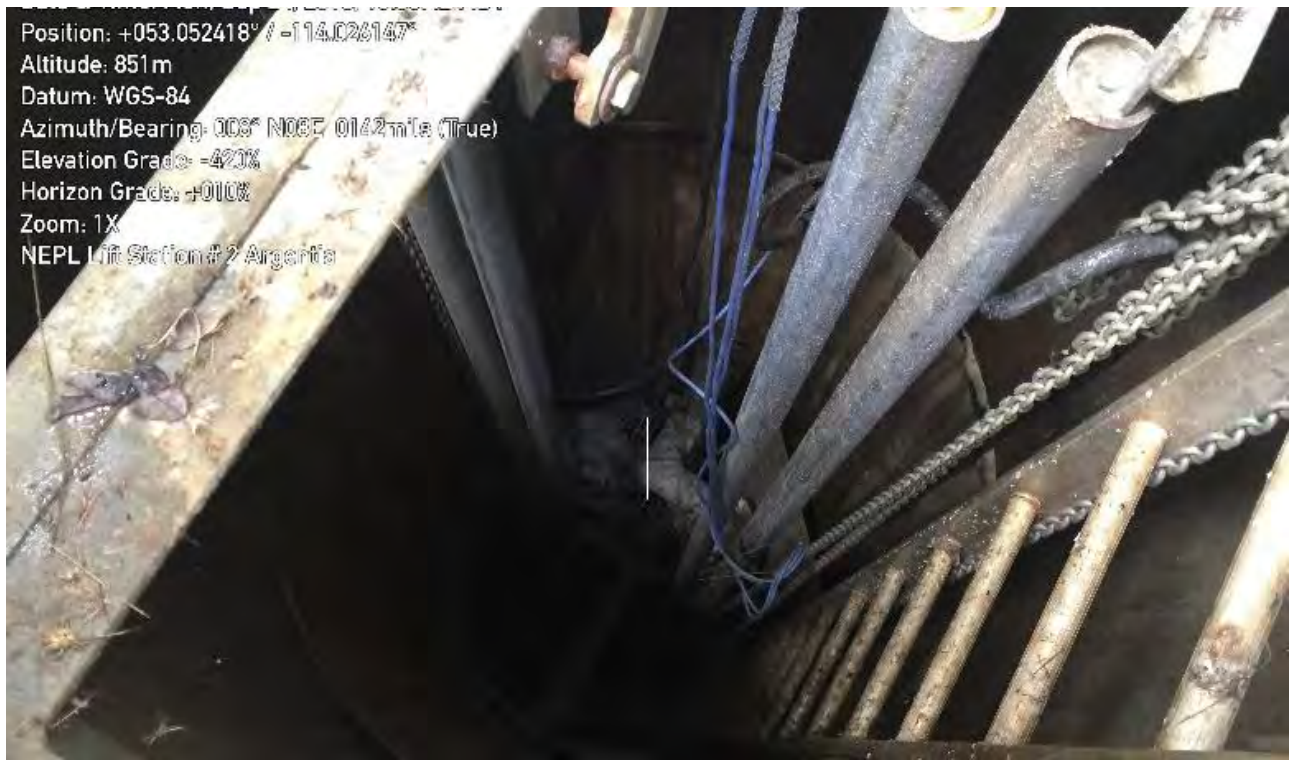
ARGENTIA BEACH LIFT STATION #2		County of Wetaskiwin North East Pigeon Lake Wastewater Collection System Assessment		Approx. year of installation	Typ. Life Expectancy (yrs)	Condition Grade	estimate remaining life (yrs)	Estimated costs in next 2+ years	Estimated costs in next 5+ years	Estimated costs in 10+ years
2018	Component	Description	Comments							
Sanitary Lift Station Assessment	Layout	Drawings	Flight package lift station, drawings are available	drawings are dated 1989						
		Safety/security	Site is Locked, Electrical panel has access security, site has alarm call outs.	site is secure	N/A	N/A	N/A	N/A	N/A	N/A
		Shelter	Site has a wood fence with a tin roof mounted on fence. Roof has open gable ends.	Fence and roof are in good condition	N/A	10+	2	5+	\$2,000.00	
		Site location	Located just off 59th Ave on the south side of the road on a undeveloped road right of way	N/A						
	Wet Well information	Dimensions	The wet well is 1.65m inside diameter, and total depth is 6.09 m from lid to WW floor. Active storage depth is 1.79m	N/A

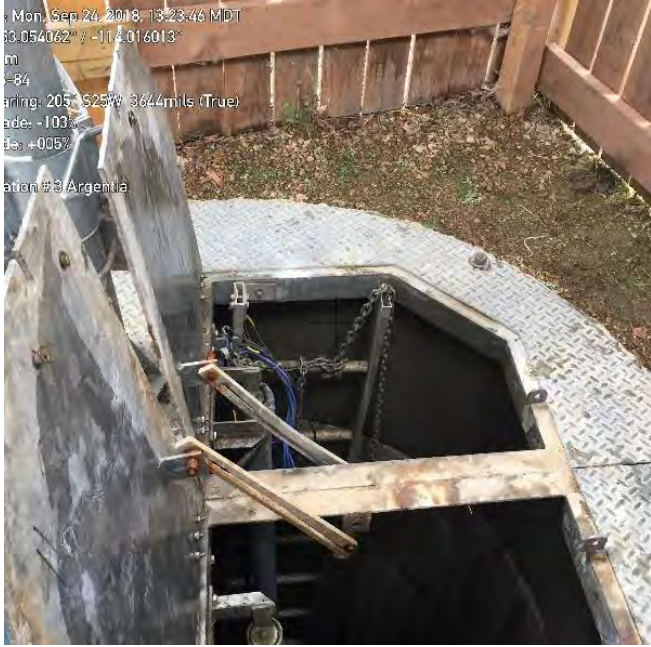
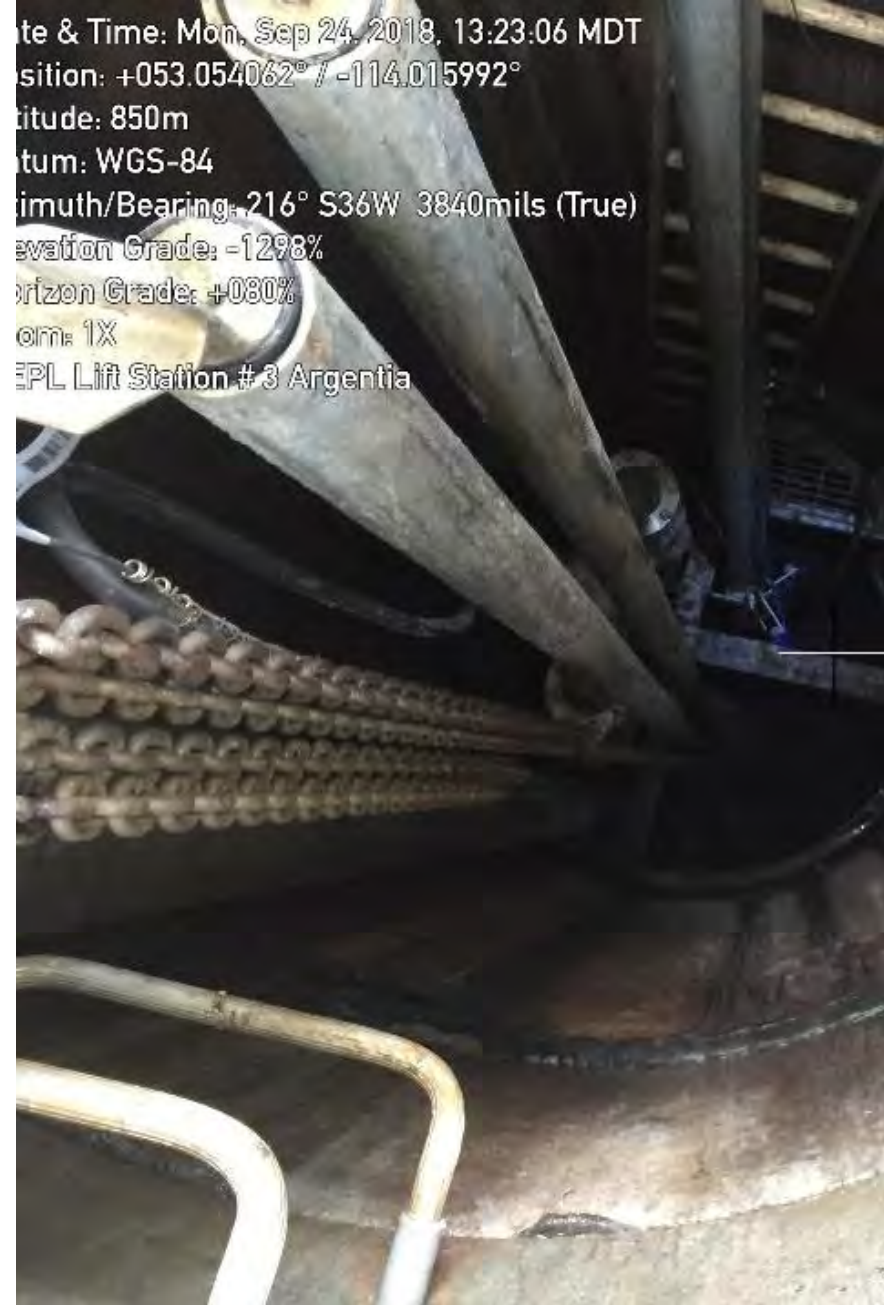
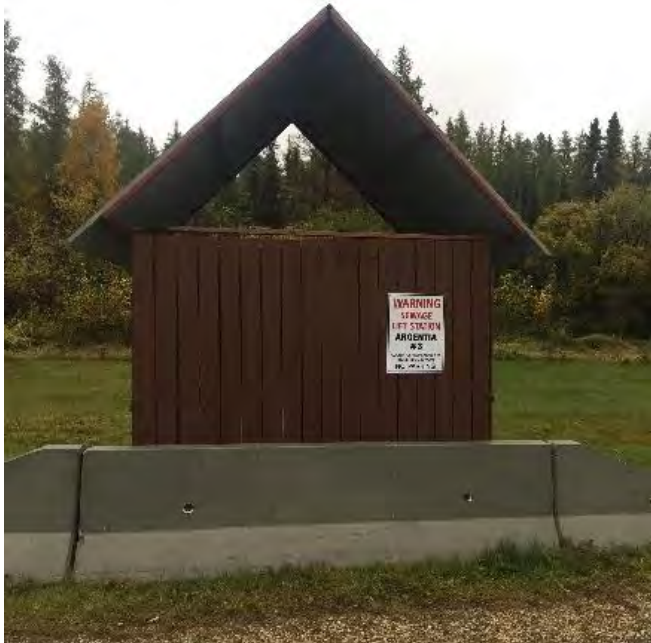
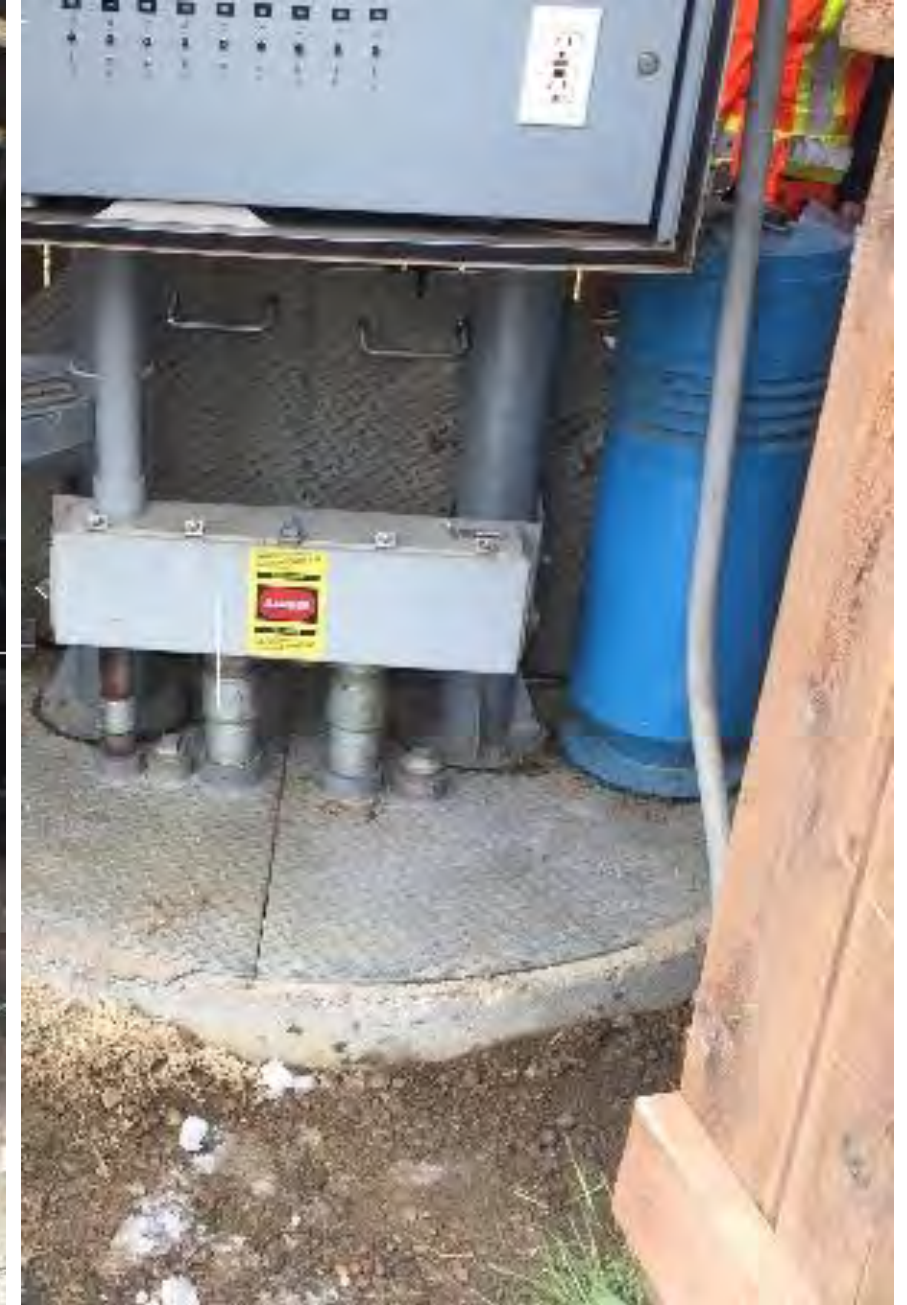
ARGENTIA BEACH LIFT STATION #3				County of Wetaskiwin North East Pigeon Lake Wastewater Collection System Assessment				Approx. year of installation	Typ. Life Expectancy (yrs)	Condition Grade	estimate remaining life (yrs)	Estimated costs in next 2+ years	Estimated costs in next 5+ years	Estimated costs in 10+ years
2018		Component	Description	Comments										
Sanitary Lift Station Assessment	Layout	Drawings	Flight package lift station, drawings are available	drawings are dated 1989										
		Safety/security	Site is Locked, Electrical panel has access security, site has alarm call outs.	site is secure	N/A	N/A	N/A	N/A	N/A	N/A	N/A			
		Shelter	Site has a wood fence with a tin roof mounted on fence. Roof has open gable ends.	Fence and roof are in good condition	N/A	10+	2	5+		\$2,000.00				
		Site location	Located just off 59th Ave on the edge of the road right of way.	existing barriers installed

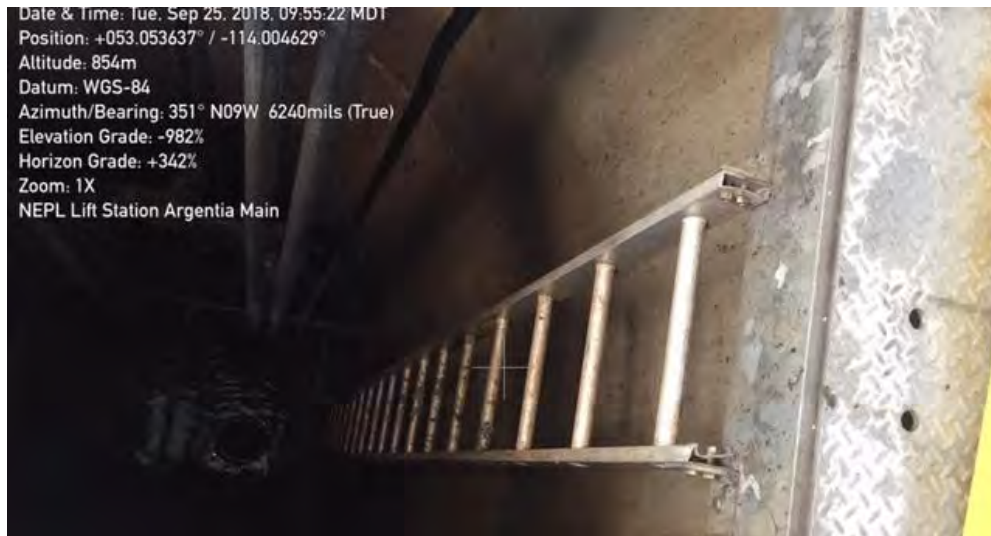
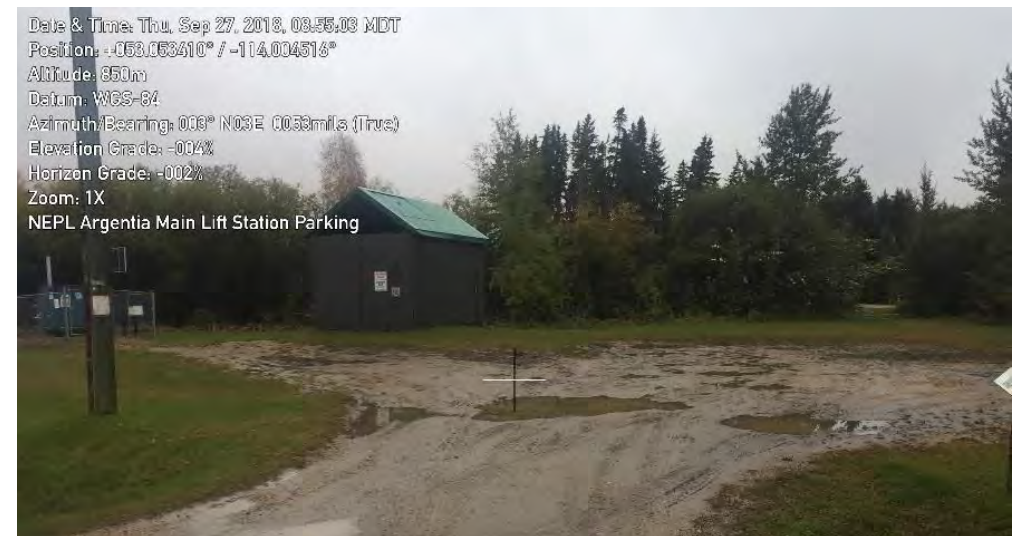
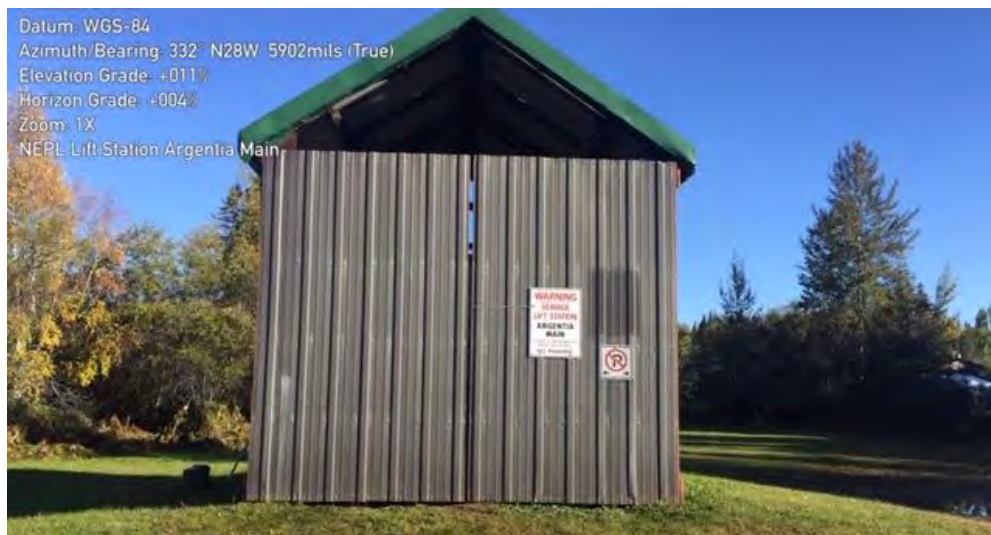
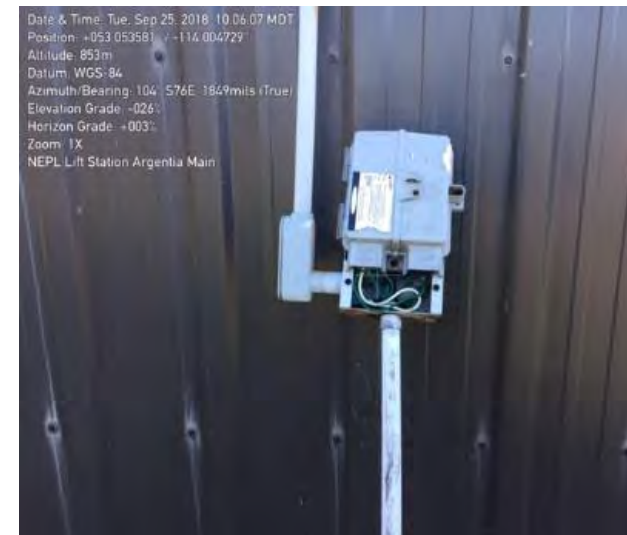
ARGENTIA MAIN LIFT STATION		County of Wetaskiwin North East Pigeon Lake Wastewater Collection System Assessment		Approx. year of installation	Typ. Life Expectancy (yrs)	Condition Grade	estimate remaining life (yrs)	Estimated costs in next 2+ years	Estimated costs in next 5+ years	Estimated costs in 10+ years
2018	Component	Description	Comments							
Sanitary Lift Station Assessment	Layout	Drawings	Flygt package lift station, drawings are available	drawings are dated 1989						
		Safety/security	Site is Locked, Electrical panel has access security, site has alarm call outs.	site is secure	N/A	N/A	N/A	N/A	N/A	N/A
		Shelter	Site has a metal frame shelter with metal cladding consisting of four walls and an open gable ends roof. The is a service entrance with tow large doors as well as a smaller man door	metal frame has minor rusting other wise shelter is in good condition	N/A	10+	1	10+		\$20,000.00

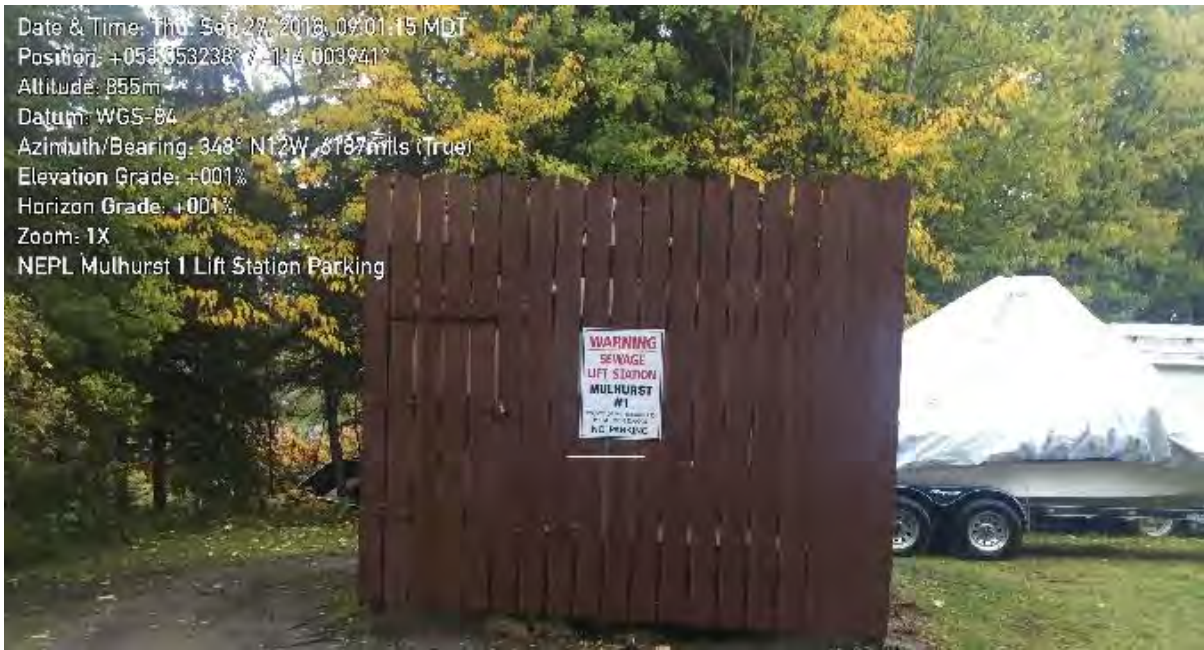
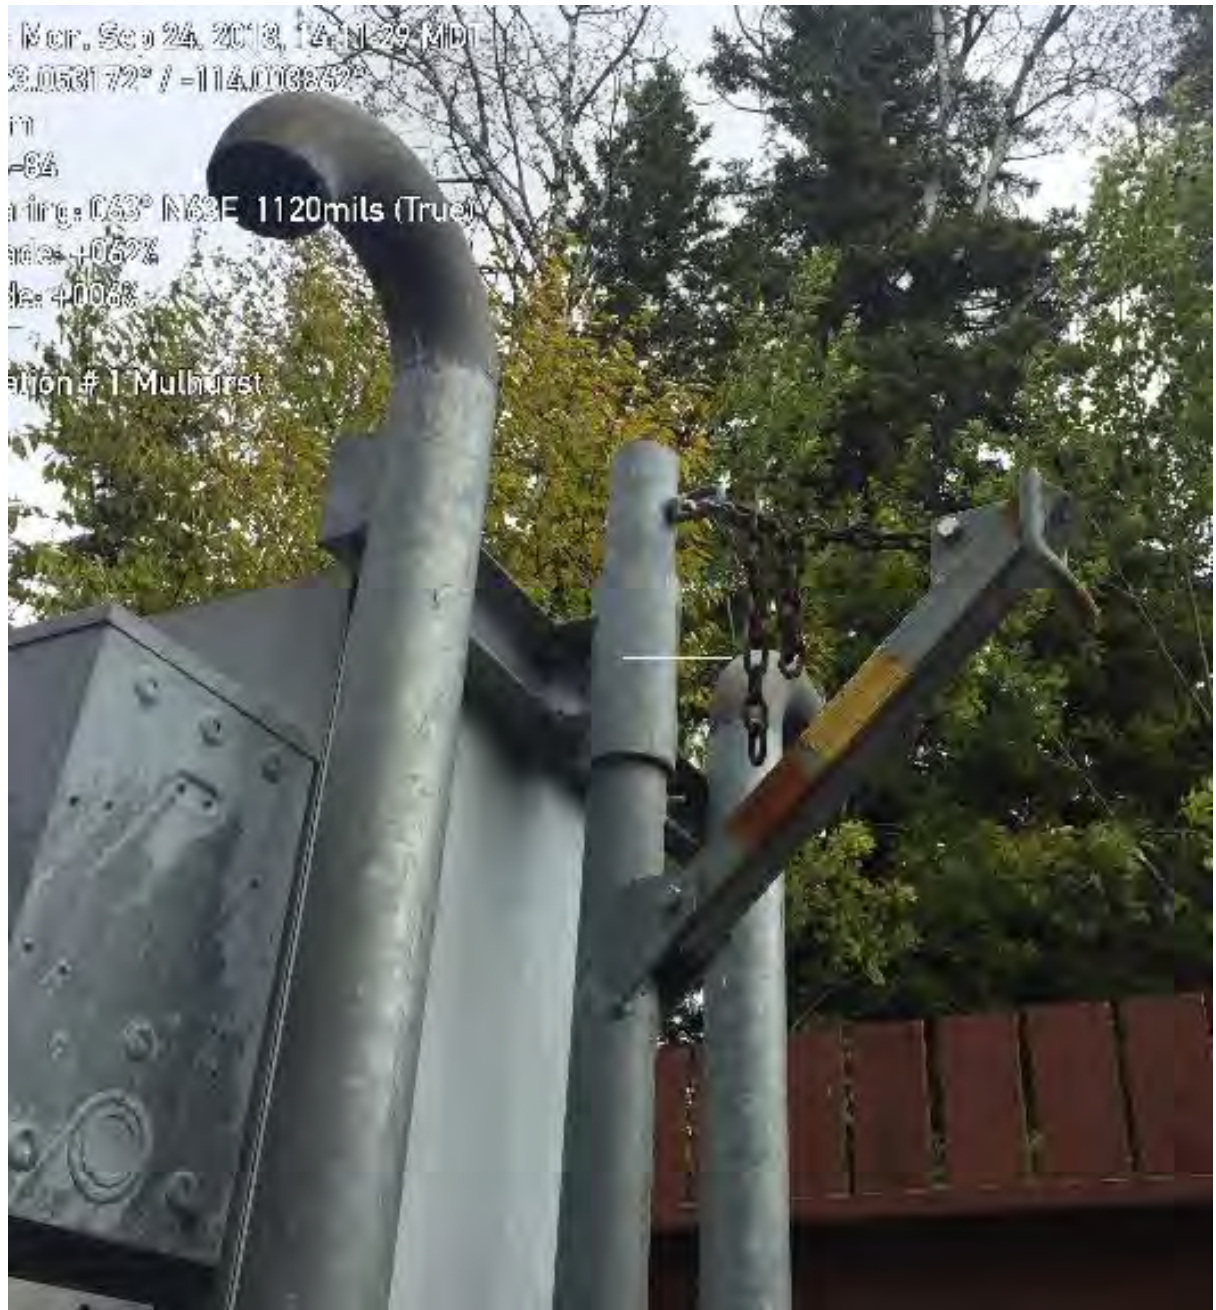
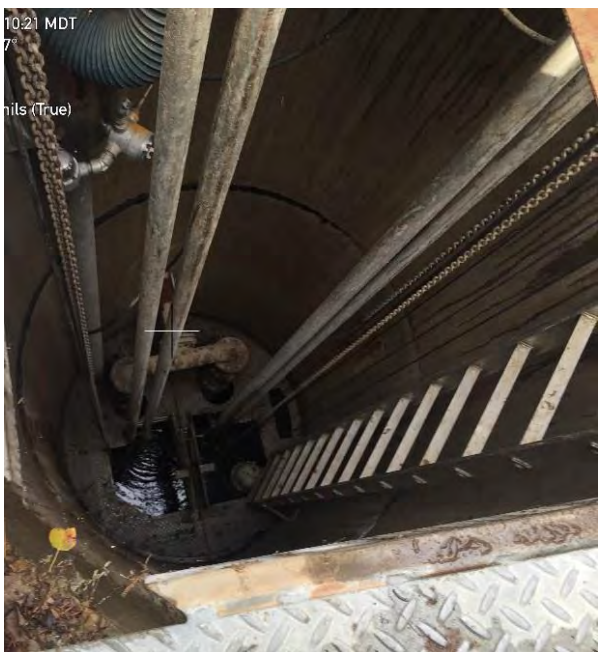
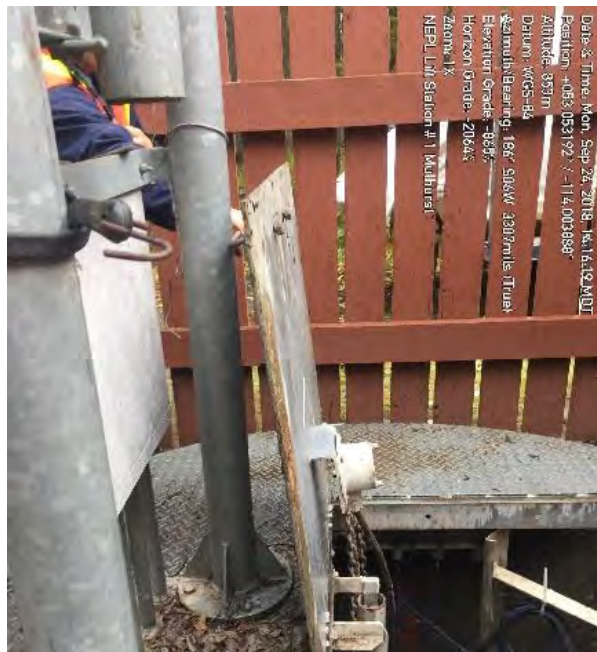
MULHURST LIFT STATION #1		County of Wetaskiwin North East Pigeon Lake Wastewater Collection System Assessment		Approx. year of installation	Typ. Life Expectancy (yrs)	Condition Grade	estimate remaining life (yrs)	Estimated costs in next 2+ years	Estimated costs in next 5+ years	Estimated costs in 10+ years
2018	Component	Description	Comments							
Sanitary Lift Station Assessment	Layout	Drawings	Flight package lift station, drawings are available	drawings are dated 1985						
		Safety/security	Site is Locked, Electrical panel has access security, site has alarm call outs.	site is secure	N/A	N/A	N/A	N/A	N/A	N/A
		Shelter	has a tall wood fence , no roof on top. Fence has man gate as well as two large swinging gates with service truck access	Fence is in reasonable condition	N/A	10+	1	5+	\$1,500.00	
		Site location	Located on its on lot at the intersection of 52 Street and 59th Ave, has a small gravel access, with trees on the north and east side	Recommend bollards be installed on road side to protect the site				\$1,000.00
