COUNTY OF WETASKIWIN
REPORT NUMBER: 181-10883-00

NEPL WASTEWATER & INFRASTRUCTURE ASSESSMENT FINAL DRAFT

MAY 01, 2019

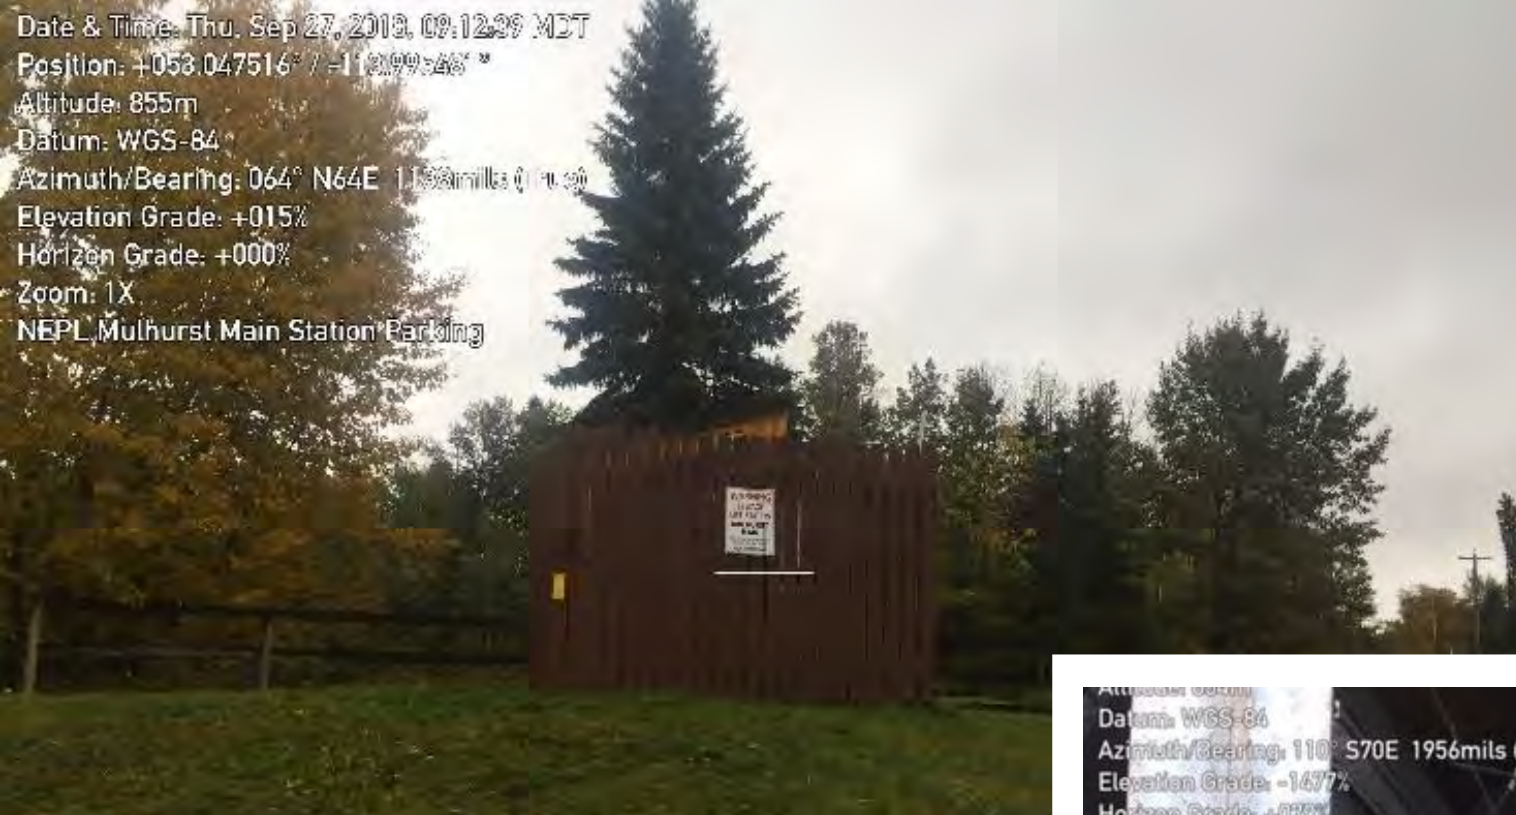
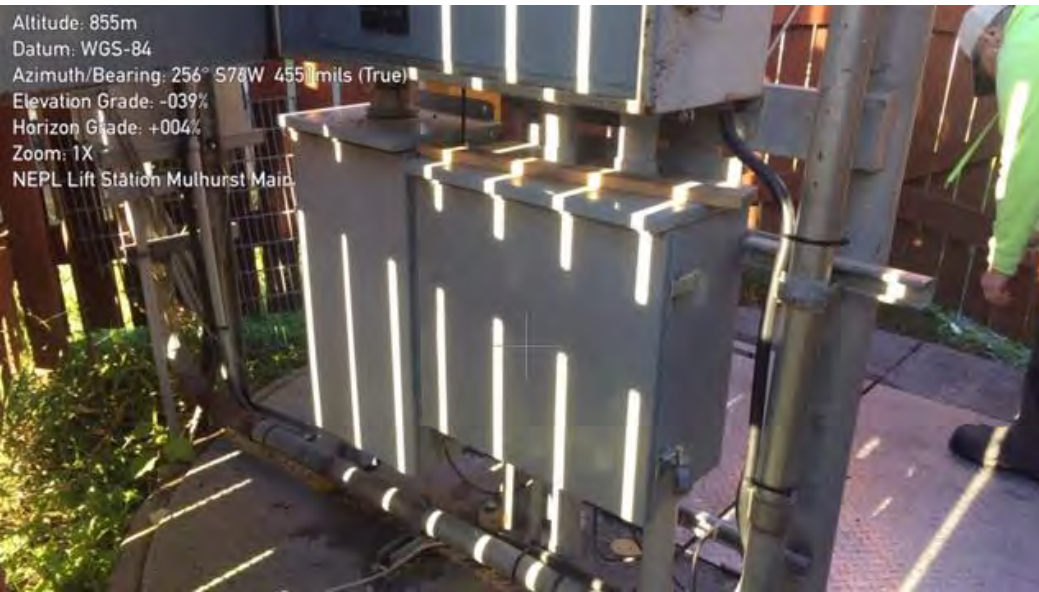
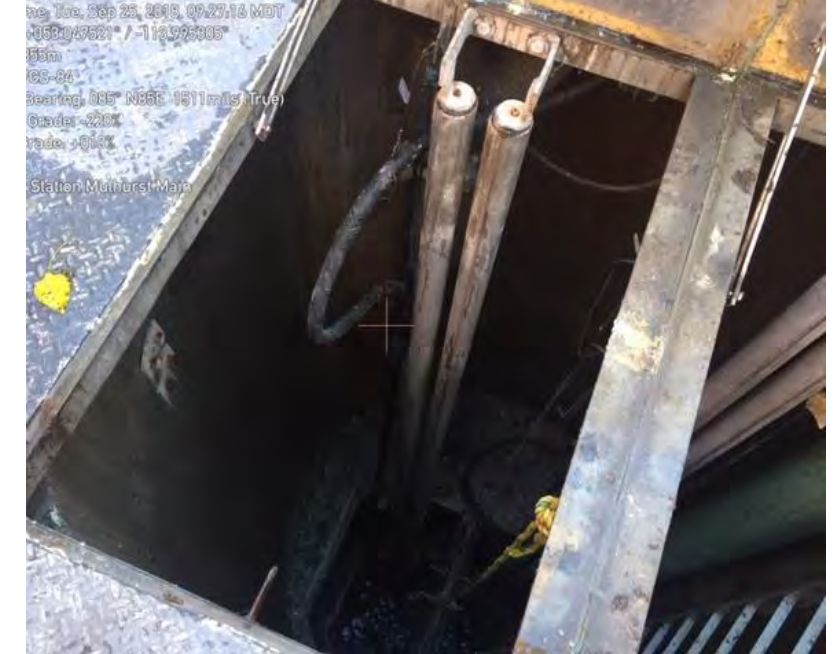
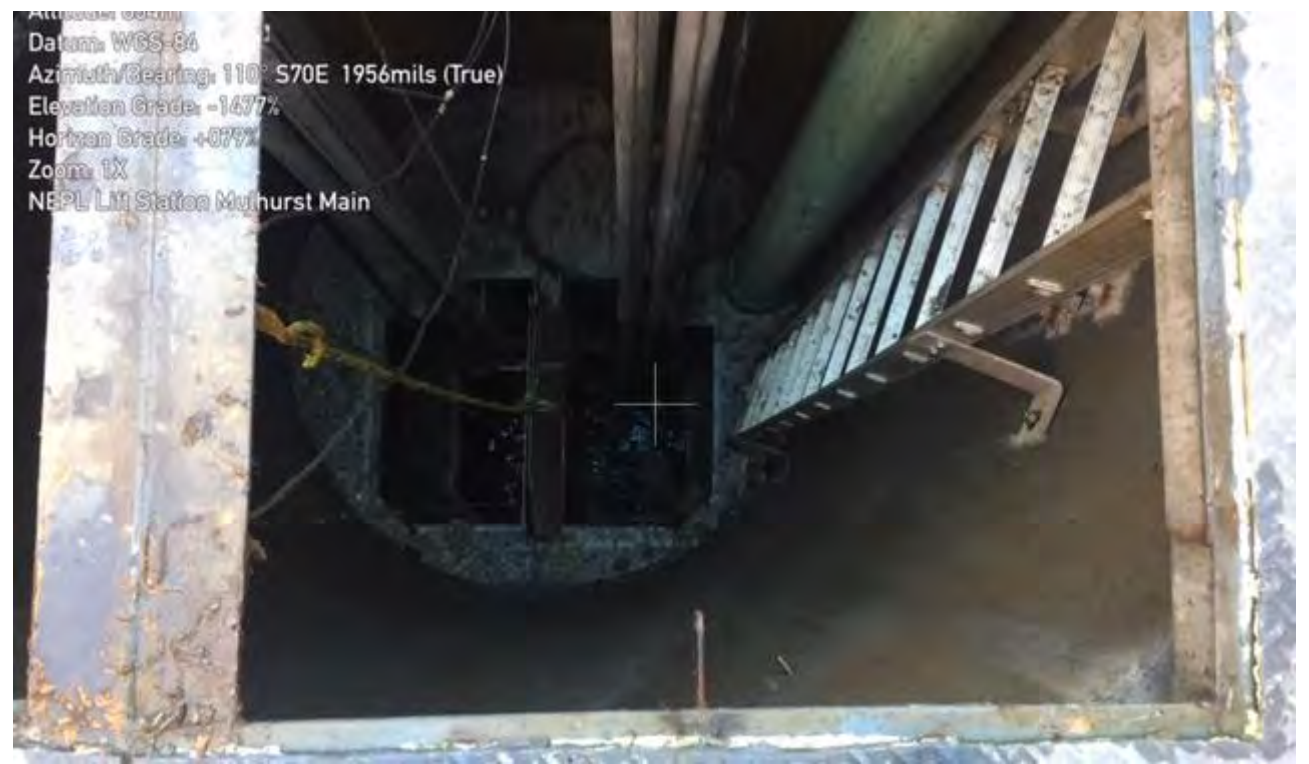
MULHURST MAIN LIFT STATION #2			County of Wetaskiwin North East Pigeon Lake Wastewater Collection System Assessment				Approx. year of installation	Typ. Life Expectancy (yrs)	Condition Grade	estimate remaining life (yrs)	Estimated costs in next 2+ years	Estimated costs in next 5+ years	Estimated costs in 10+ years
2018	Component	Description	Comments										
Sanitary Lift Station Assessment	Layout	Drawings	Flight package lift station, drawings are available	most recent drawings are dated 1994									
		Safety/security	Site is Locked, Electrical panel has access security, site has alarm call outs.	site is secure	N/A	N/A	N/A	N/A	N/A	N/A	N/A		
		Shelter	Site has a wood fence and no roof	Fence is in good condition, requires full electrical building	N/A	10+	2	5+	\$100,000.00				
		Site location	Located on the lane intersection of Lake drive and 50 Ave. It is in its own utility right of way. There is a small gravel access for a service vehicle	Recommend bollards be installed on road side to protect the site					\$1,000.00

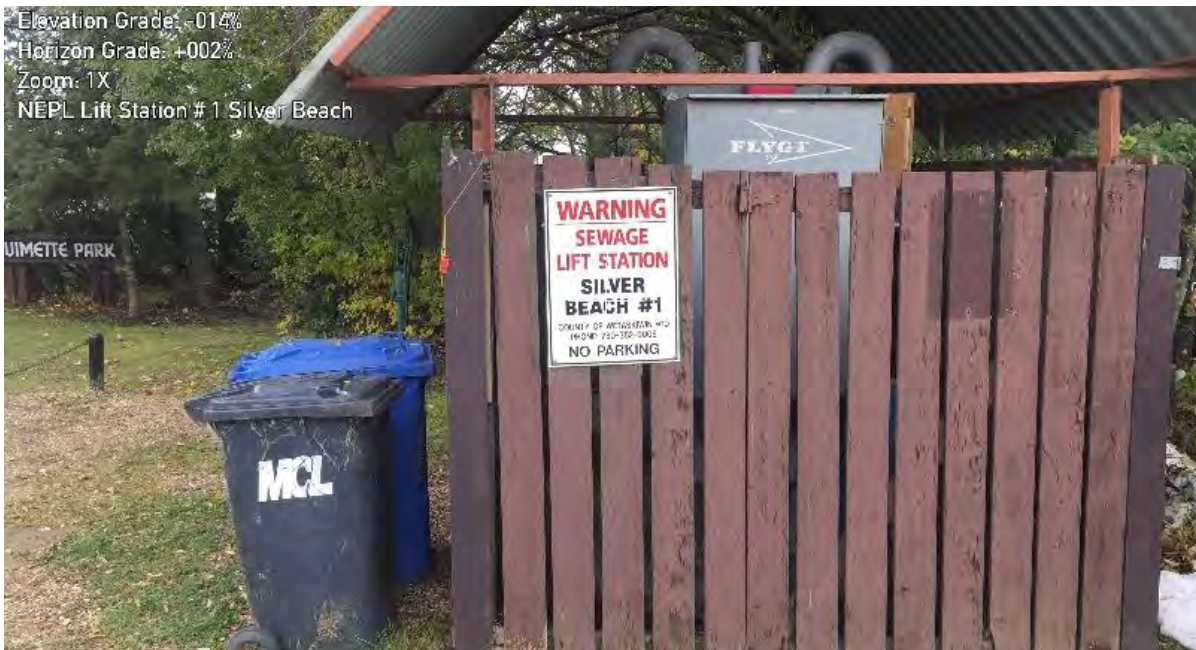
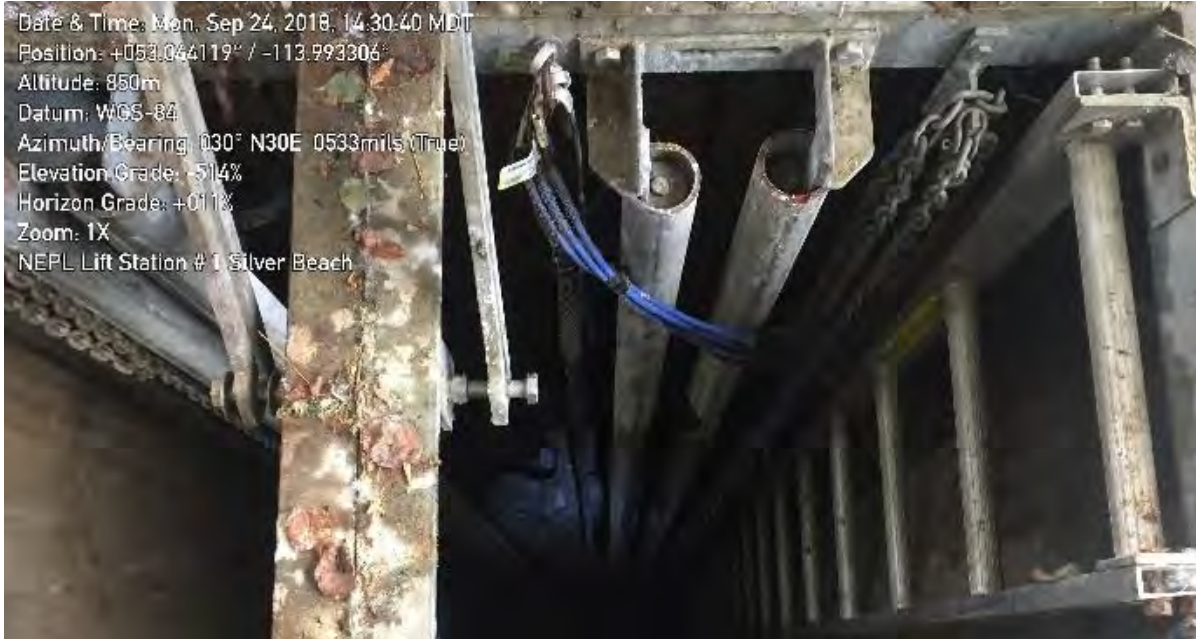
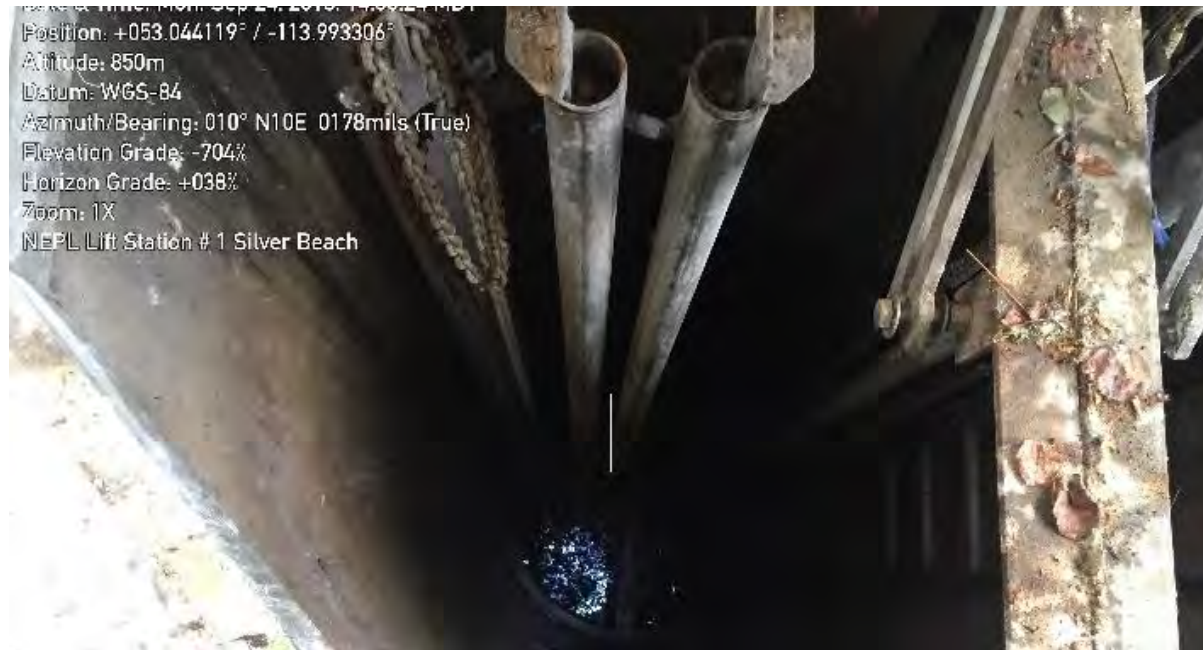
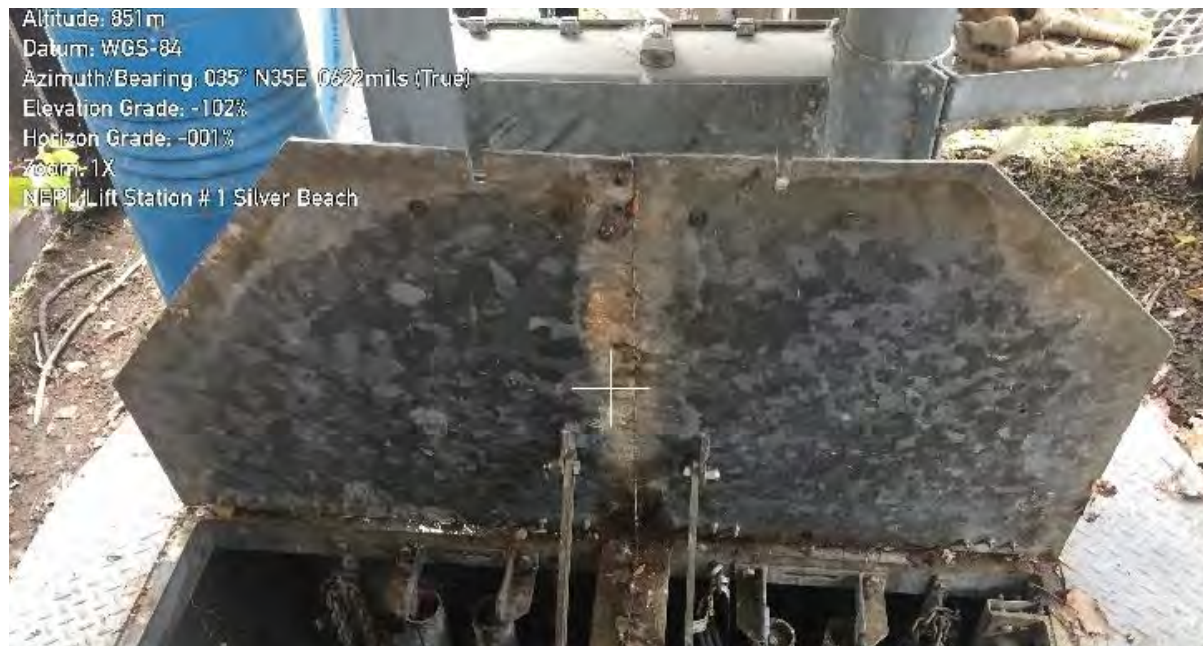
SILVER BEACH LIFT STATION #1		County of Wetaskiwin North East Pigeon Lake Wastewater Collection System Assessment		Approx. year of installation	Typ. Life Expectancy (yrs)	Condition Grade	estimate remaining life (yrs)	Estimated costs in next 2+ years	Estimated costs in next 5+ years	Estimated costs in 10+ years
2018	Component	Description	Comments							
Sanitary Lift Station Assessment	Layout	Drawings	Flight package lift station, drawings are available	drawings are dated 1989						
		Safety/security	Site is Locked, Electrical panel has access security, site has alarm call outs.	site is secure	N/A	N/A	N/A	N/A	N/A	N/A
		Shelter	Site has a wood fence with a tin roof mounted on fence. Roof has open gable ends.	Fence may need to be replaced soon, roof is in ok condition	N/A	2+	1	5+	\$3,000.00	
		Site location	Located on the edge of Silver Beach Rd in the edge of the road right of way, has a asphalt pavement on one side and is treed in on the other. Close to a property	Recommend bollards be installed on road side to protect the site					\$1,000.00

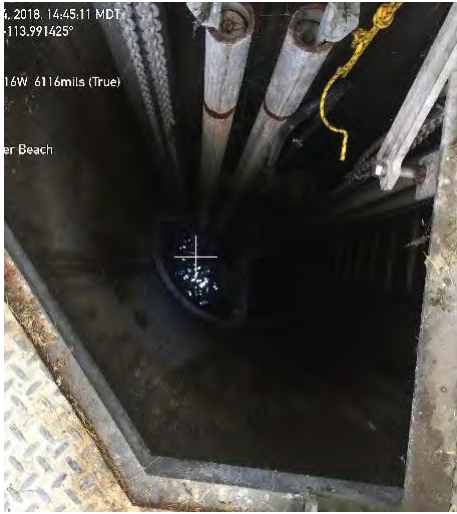
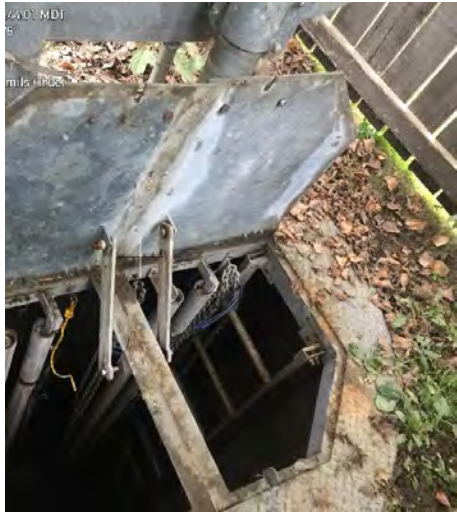
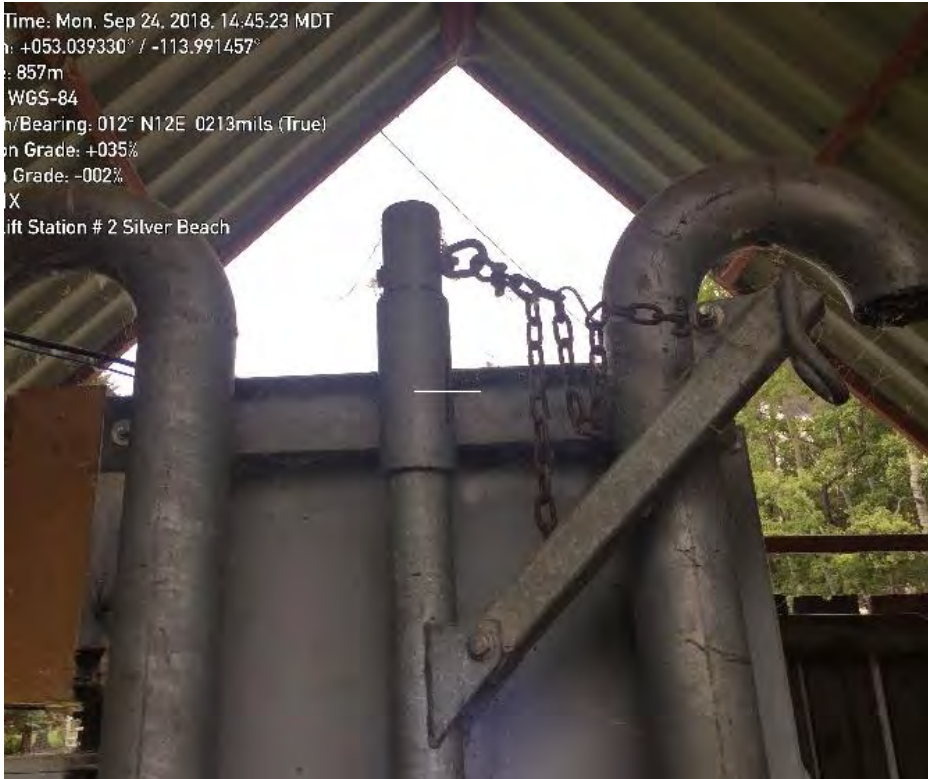
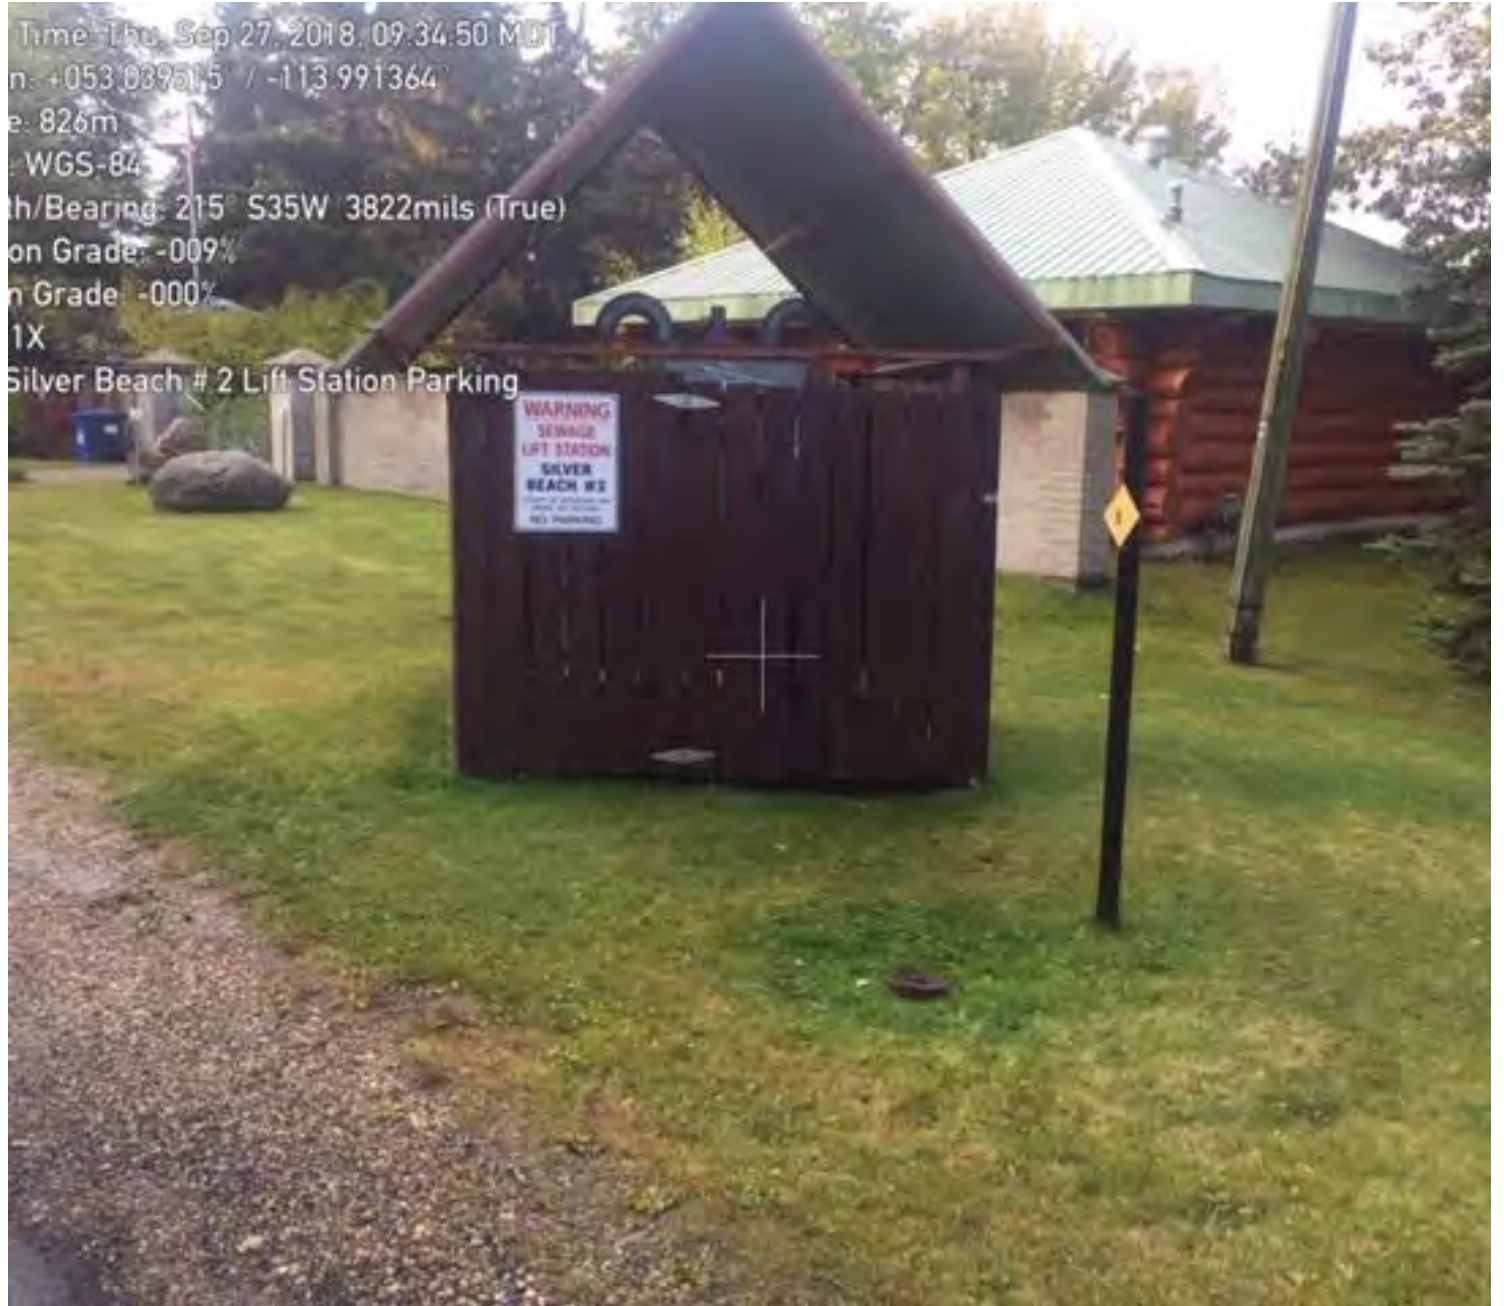
SILVER BEACH LIFT STATION #2			County of Wetaskiwin North East Pigeon Lake Wastewater Collection System Assessment		Approx. year of installation	Typ. Life Expectancy (yrs)	Condition Grade	estimate remaining life (yrs)	Estimated costs in next 2= years	Estimated costs in next 5+ years	Estimated costs in 10+ years
2018	Component		Description	Comments							
Sanitary Lift Station Assessment	Layout	Drawings	Flight package lift station, drawings are available	drawings are dated 1989							
		Safety/security	Site is Locked, Electrical panel has access security, site has alarm call outs.	site is secure	N/A	N/A	N/A	N/A	N/A	N/A	N/A
		Shelter	Site has a wood fence with a tin roof mounted on fence. Roof has open gable ends.	Fence may need to be replaced soon, roof is in ok condition slight rusting on framing	N/A	2+	1	5+	\$3,000.00		
		Site location	Located on the edge of Silver Beach Rd in the edge of the road right of way, has a asphalt pavement on one side and private property close to the other side.	Recommend bollards be installed on road side to protect the site

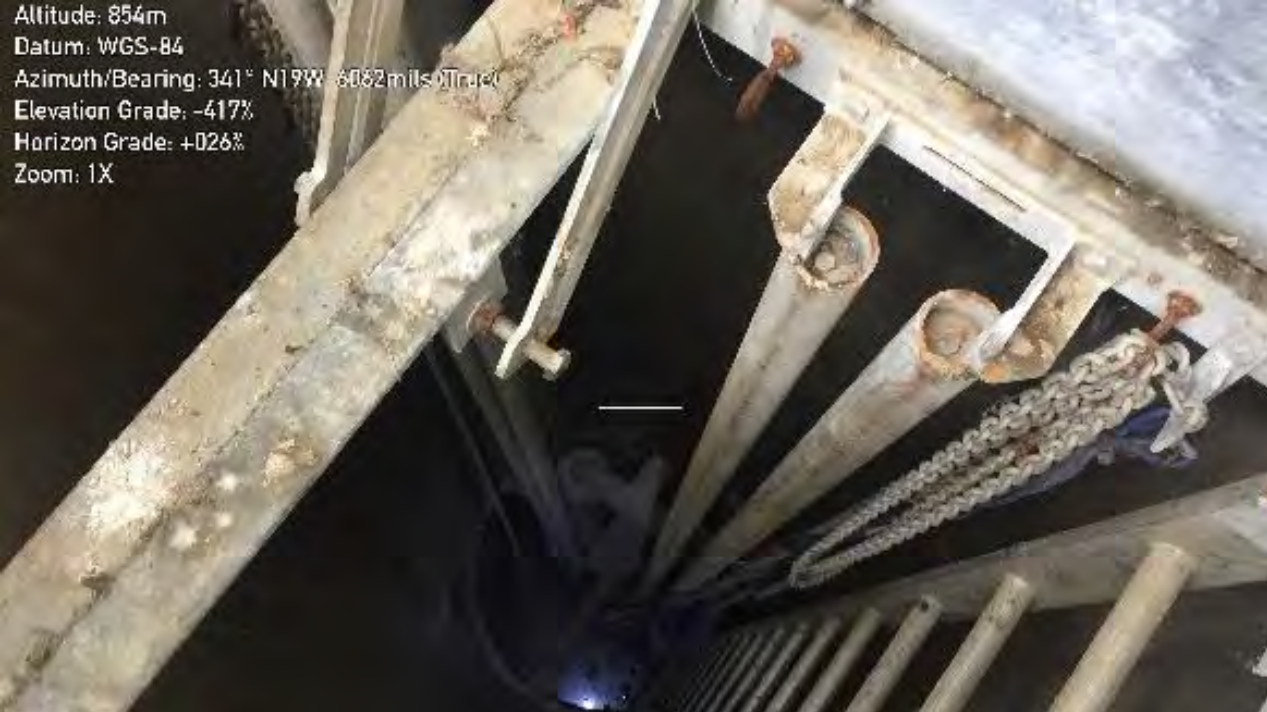
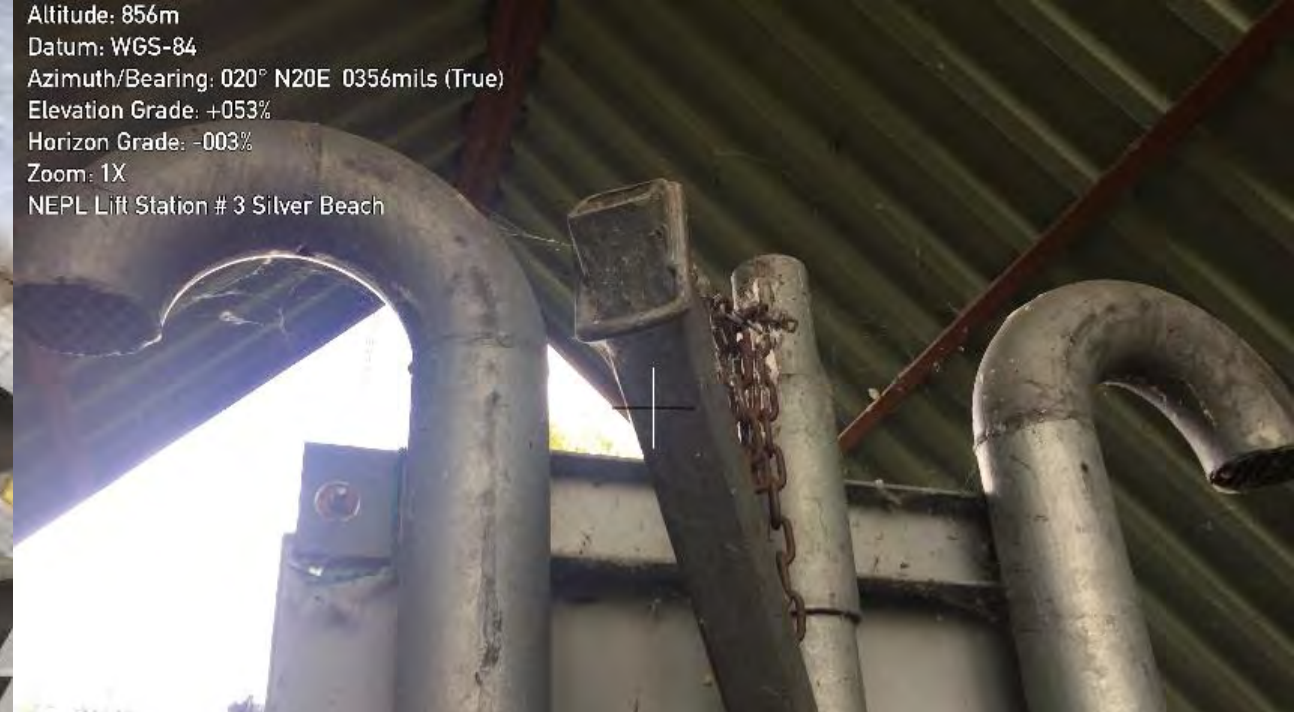
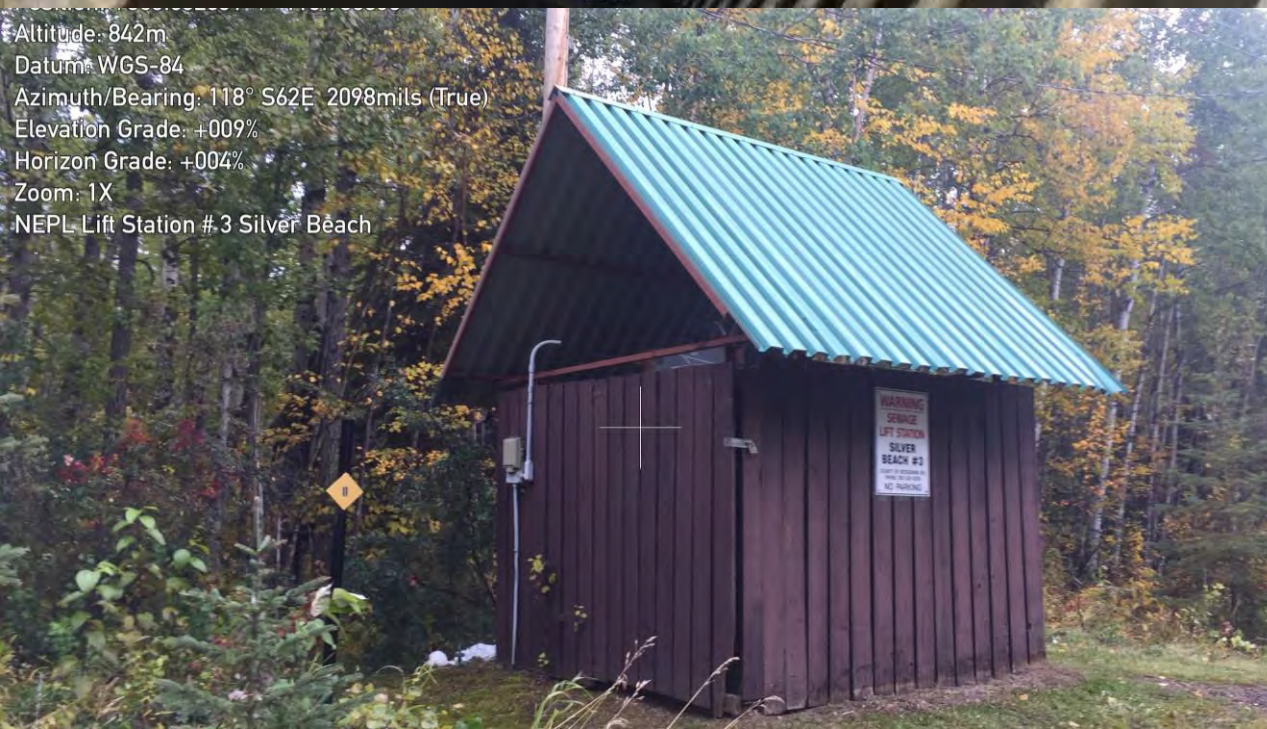
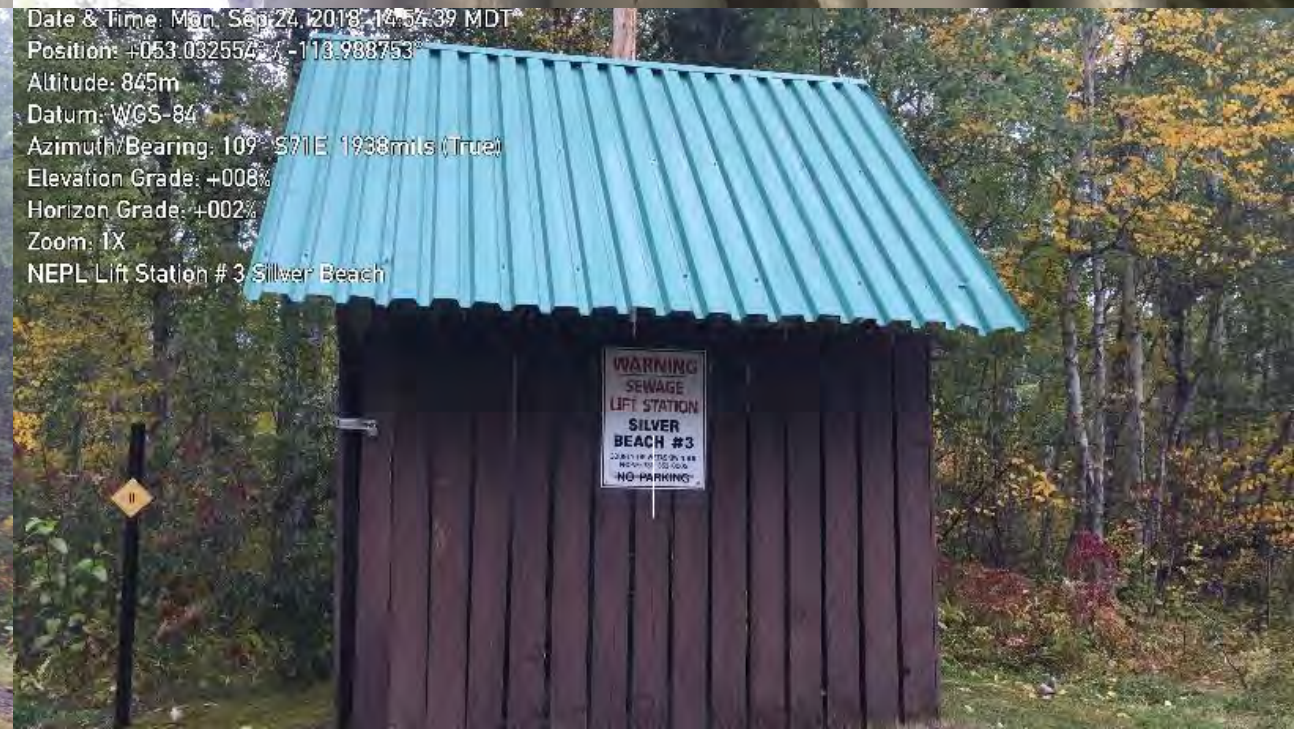
SILVER BEACH LIFT STATION #3		County of Wetaskiwin North East Pigeon Lake Wastewater Collection System Assessment		Approx. year of installation	Typ. Life Expectancy (yrs)	Condition Grade	estimate remaining life (yrs)	Estimated costs in next 2= years	Estimated costs in next 5+ years	Estimated costs in 10+ years
2018	Component	Description	Comments							
Sanitary Lift Station Assessment	Layout	Drawings	Flight package lift station, drawings are available	drawings are dated 1989						
		Safety/security	Site is Locked, Electrical panel has access security, site has alarm call outs.	site is secure	N/A	N/A	N/A	N/A	N/A	N/A
		Shelter	Site has a wood fence with a tin roof mounted on fence. Roof has open gable ends.	Fence may need to be replaced soon, roof is in ok condition	N/A	2+	1	5+	\$3,000.00	
		Site location	Located on the edge of Silver Beach Rd in the edge of the road right of way, has a asphalt pavement and grass on one side and is treed in on the other.	N/A
